Manhole Inspection Summary

Manhole # S13CC2024MH

Record Plat: **13CC2** Node: **024** Status: **New Manhole (Not in GIS)** Insp Date: **7/26/06 12:00 AM**

Location Address: **5708 UFFINGTON RD**

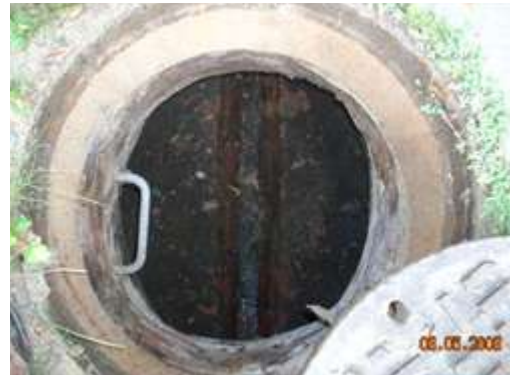
Top View

Evidence of surcharge - Bench debris.
Channel debris.

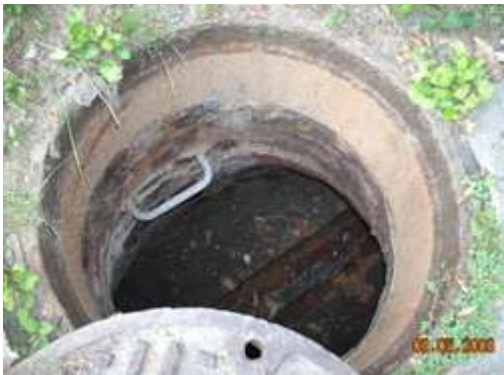
Defect

Frame leaks. Adjustment deterioration
and infiltration. Corbel and Barrel
infiltration.

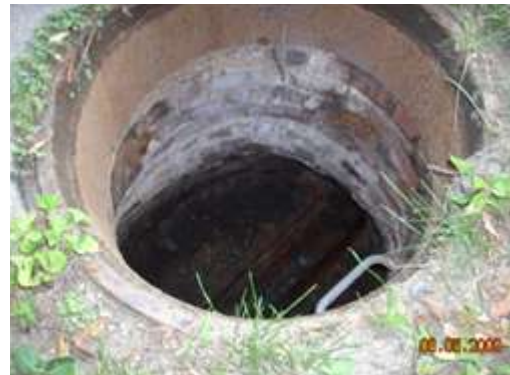
Defect

Frame leaks. Adjustment deterioration,
root intrusion and infiltration. Corbel and
Barrel infiltration - other side.

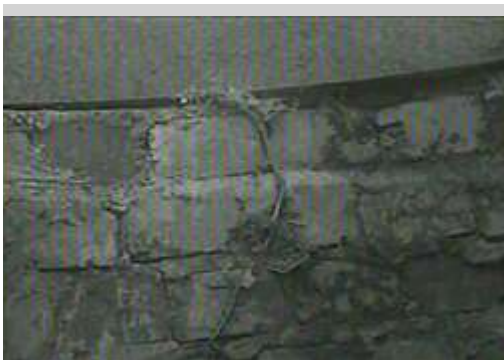
Defect

Frame leaks. Adjustment deterioration,
root intrusion and infiltration.

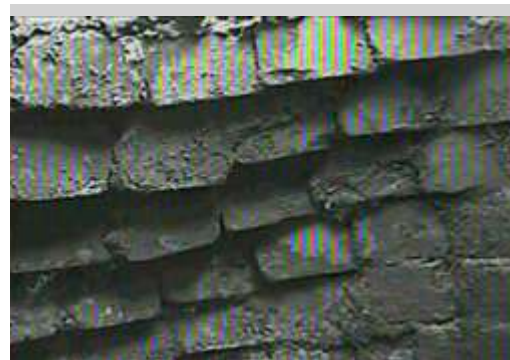
Defect

Corbel and Barrel deterioration and
infiltration.

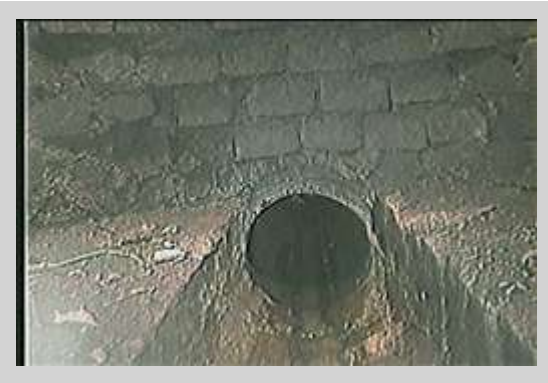
8 in. Circular Gravity Sewer Pipe Out @ 12 O'Clock

Barrel deterioration and infiltration.

Infiltration: **None** Pipe Seal Cond: **Cracked**

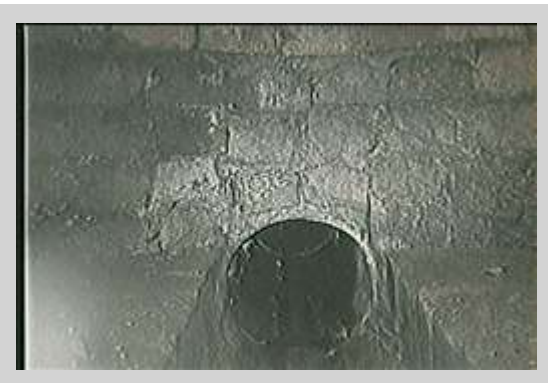
8 in. Circular Gravity Sewer Pipe In @ 6 O'Clock

Channel root intrusion.

Infiltration: **None** Pipe Seal Cond: **Cracked**
